Technical Information

Burn Marks on Commutator Surfaces

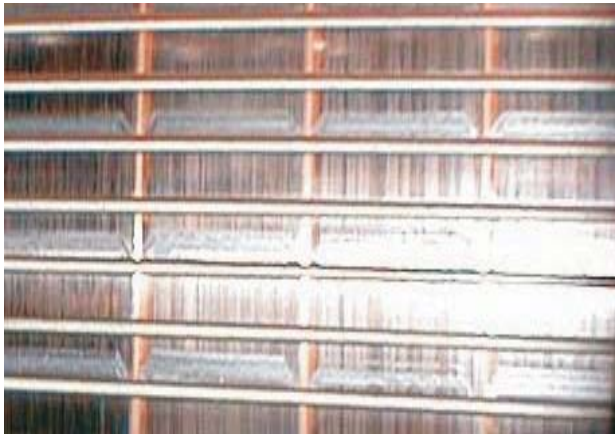
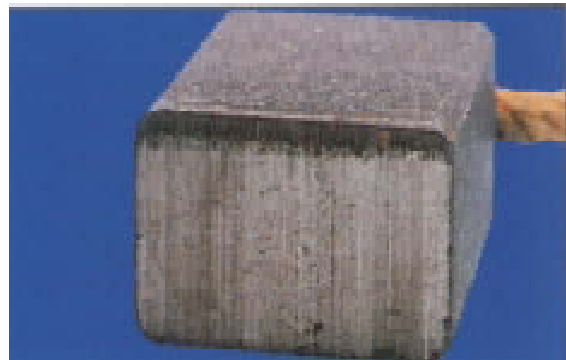
These blurs distinguish themselves significantly from all other kind of blurs, which will be described later: they are sharp-edged, overlap approximately half of the bar and are trapezoidal.

Blurs or burn marks caused by commutation problems are normally to be seen in regular distances at the trailing edge of the commutator bars. Sometimes, depending on the design of the rotor winding, every third, fourth or fifth is affected.

- Check and if applicable adjustment of the neutral zone
- Check and if applicable adjustment of the interpole (interpole air gap)
- Check of the control device
- Check of the brush grade and
- Check of the brush design

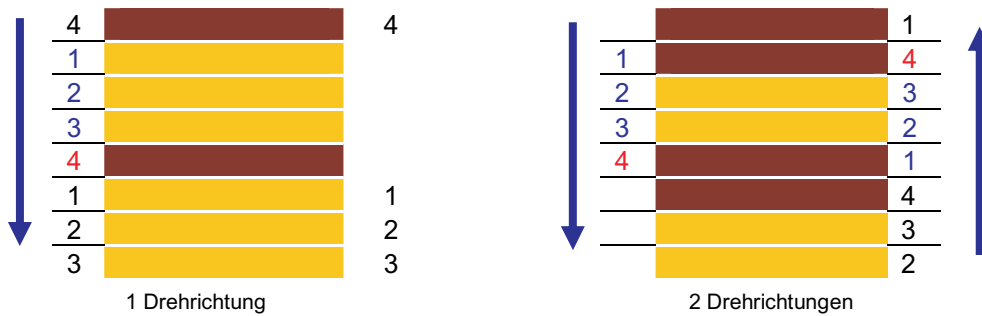
Motors with two turning directions show discolorations according to right sketch below.

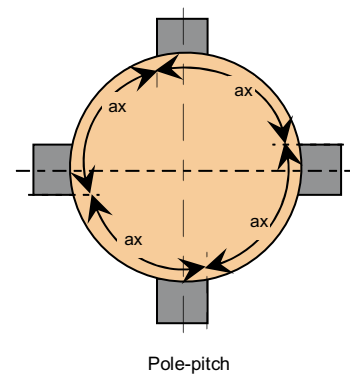
Often “commutator blurs in pole-pitch” can be observed, in an advanced state also “out-of-roundness in pole-pitch”. Pole pitch is the distance between the brush arms. Here one bar is more burned than the adjacent one – accidentally or by means of electrical or mechanical abnormalities (e.g. by resistance differences due to unbalances in the winding, commutator deformations etc.). The current transfer at this bar is disturbed, the electrically parallel brushes of the same polarity have to transfer more current and are thereby overloaded.

Advanced burn marks in pole-pitch also appear in an out-of-roundness measurement.

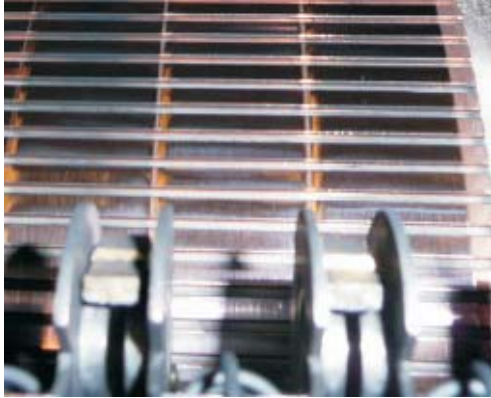
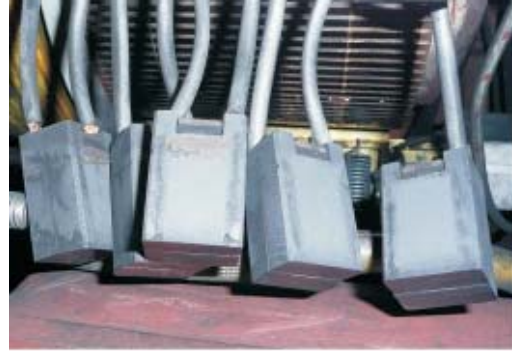
Brush sparking caused by vibrations triggers a slightly different commutator pattern. The blurs and burn marks are not sharp-edged but rather washy. The whole bar can be affected and particularly the burn marks are not regularly distributed on the commutator perimeter. (see also picture T12, T14 in the illustrations of commutator states of the well known carbon brush suppliers).

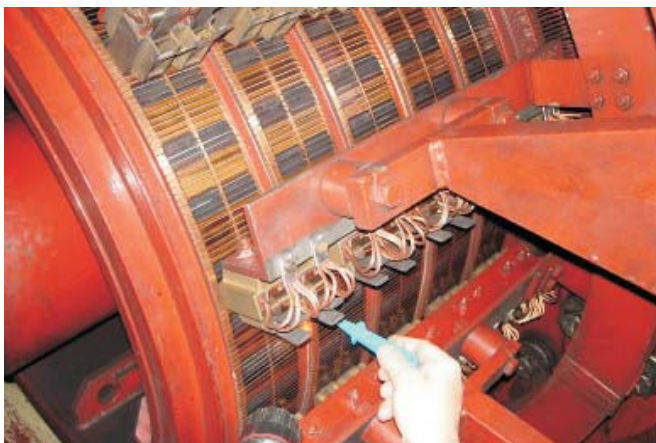
Broken commutator lead

Loosen or high resistance connections between the armature winding and the commutator bars cause burn marks, starting at the bar directly adjacent to the segment with the broken lead. The contact between brush and commutator gets worse and the whole commutator shows more and more sign of burning. In an advanced state flat spots and burn marks will show up, regularly distributed around the commutator perimeter.

Single bars with poor film formation due to reduced current flow are an indicator for broken commutator leads.

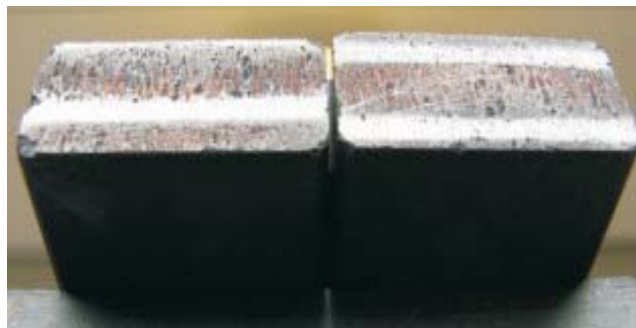
A by-product of bad commutation conditions is a special marking on the brush contact surface. The contact surface is divided in zones, each one bar width wide. That phenomenon is caused by abnormally high current density in parts of the contact surface during dedicated phases of the commutating process.

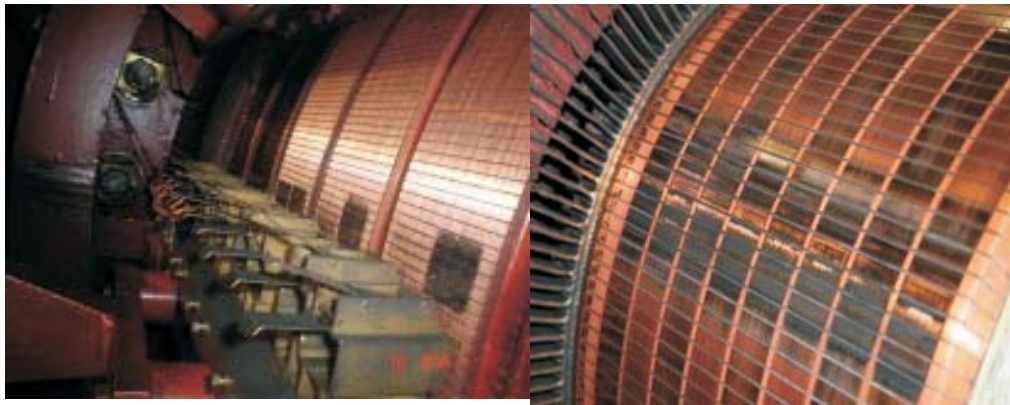
Due to the locally high temperatures in case of impermissible standstill load the copper of the commutator bar will be softened and changes its structure permanently. Thus flat spots and out-of-roundness will show up during operation.

The commutator bars will expand. Due to the arch pressure inside the commutator they will not move back to their original position while cooling down. That also causes out-of-roundness, brush vibration and further after-effects.

During standstill phases DC motors may be loaded only for a limited time to avoid damage of the commutator. At interval operation DC motor OEMs recommend a duration of max. 20 seconds at 100% overload.

It has to be considered, that standstill load in the same position of the rotor e.g. in case of restarts of blocked extruders etc. , may be repeated only, if commutator and armature are sufficiently cooled down.

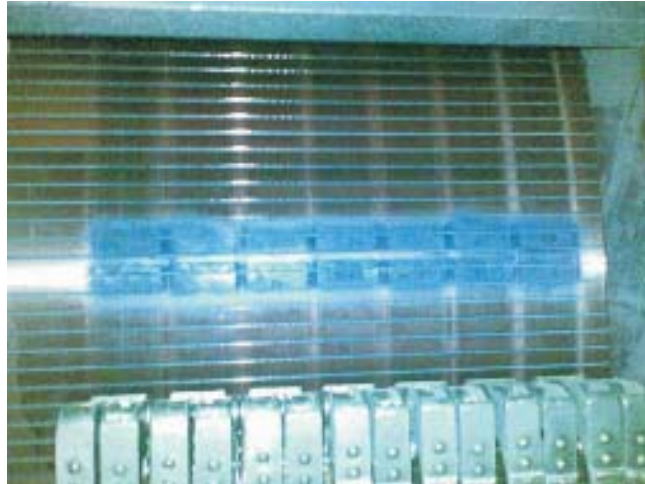
A special form of blur formation shows up on commutator surfaces during shutdown, if the combination carbon brush / commutator forms a galvanic element due to high humidity. To avoid the formation of those blurs it is strongly recommended to lift the brushes or to put an insulating pad underneath the brush contact surface during long downtime or for example in case of sea transport of new motors.
