Technical Information

Burn Marks on Commutator Surfaces

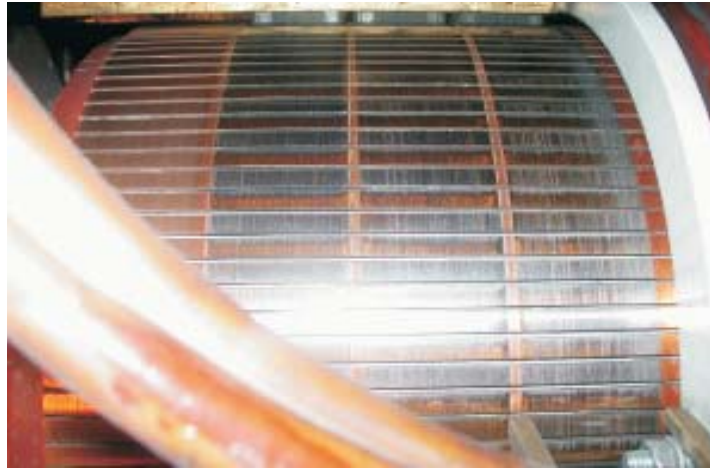
A by-product of bad commutation conditions is a special marking on the brush contact surface. The contact surface is divided in zones, each one bar width wide. That phenomenon is caused by abnormally high current density in parts of the contact surface during dedicated phases of the commutating process.
